# The Premature Deterioration of Zinc-coated Steel Pipes in Water Distribution System

B. Pawlowski, J. Krawczyk, P. Bala

AGH University of Science and Technology, Krakow, Poland

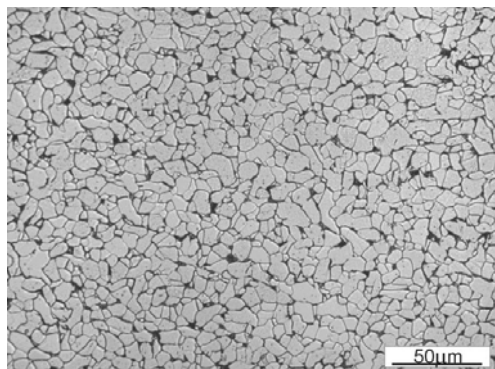
These longitudinally welded pipes were made of galvanized L235 steel and the elemental chemical composition, determined by use of Foundry-Master WAS spectrometer, do meet requirements stated in EN 10224:2004. Figure 3 shows an example of the microstructure of investigated L235 steel (transverse direction).

FIG. 3. AN EXAMPLE OF OFINVESTIGATED L235 STEEL, 2% NITAL

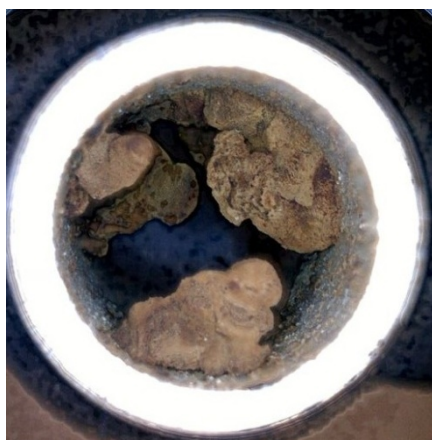
a)

Images of the deposits present in the interior of investigated pipes are shown in Figure 4. As shown, on the inner diametral surfaces the pipes were in almost all cases filled with corrosion products formed primarily as tubercles.

FIG. 4. REPRESENTATIVE EXAMPLES OF THE DEPOSITS PRESENT IN THE INTERIOR OF EXAMINED PIPES: A) REGION I PIPE, B) REGION II PIPE

In both cases, chemical analysis of the deposit showed that it consisted mainly of  $\text{Fe}_2\text{O}_3$  (74.29% for region I, 75.78% for region II). Underneath the tubercles the deep corrosion pits were found, as it is shown in Figure 5. At the corroded internal surfaces the large longitudinal perforations through the wall that followed the weldment seam are observed. As it was stated by (Wilmot et al., 2006), the process of welding creates a high strain energy region relative to the base material microstructure of the pipe and produces a locally accelerated rate of pitting corrosion so localized corrosion attack along the bond line of electric resistance welds (ERW) and flash welds (FW) leads to the development of a wedge shaped groove. Examples of cross section through such wedge shaped groove, close to the perforation area, are presented in Figure 6.

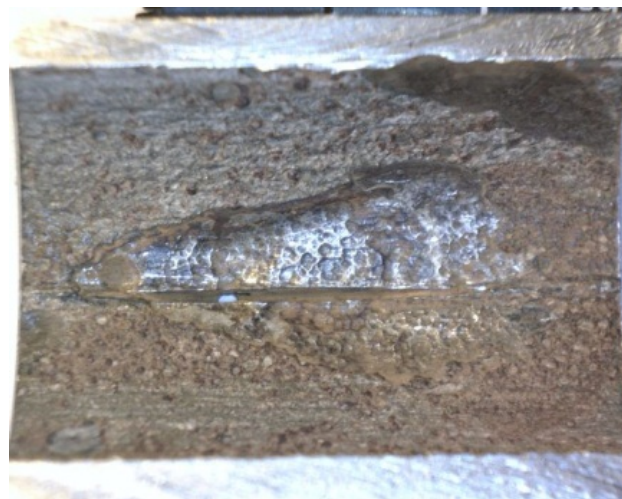
a)

FIG. 5. REPRESENTATIVE EXAMPLES OF THE DEPOSITS PRESENT IN THE INTERIOR OF EXAMINED PIPES: A) REGION I PIPE, B) REGION II PIPE

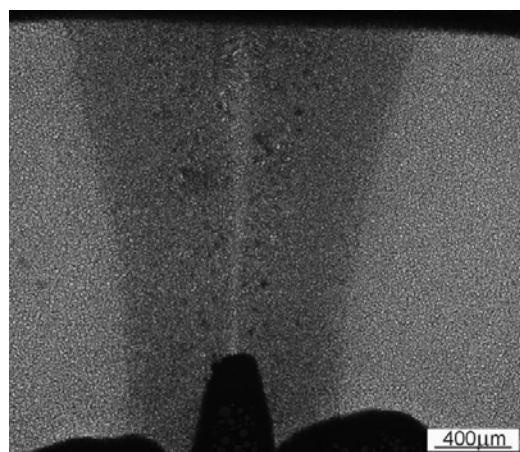
a)

FIG. 6. CROSS SECTION THROUGH THE WEDGE SHAPED GROOVE, CLOSE TO THE PERFORATION AREA, 2% NITAL

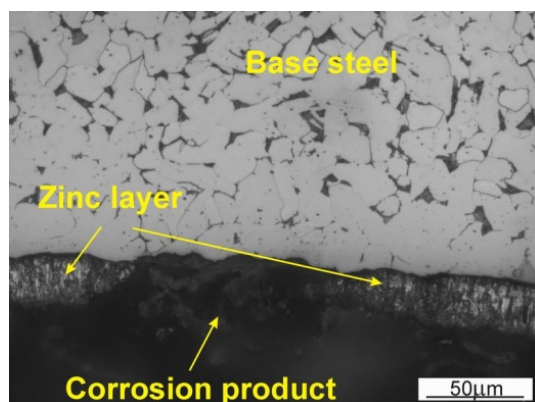
The premature corrosion failure of zinc-coated steel pipes in both examined hot water distribution systems was due to the loss of the internal protective zinc layer as most probably the result of inadequate water chemistry, which will be discussed later. An example of the break in zinc coating on the inner pipe surface which promotes further pit initiation and growth is presented in Figure 7.

FIG. 7. THE BREAK IN ZINC COATING ON THE INNER PIPE SURFACE
